**Flood Control Project Maintenance**  
**Levee Inspections**

**Fall 2011 Levee Maintenance Deficiency Summary Report**

**Sacramento River Basin**

**Sacramento Maintenance Yard Maintenance Area 0009**

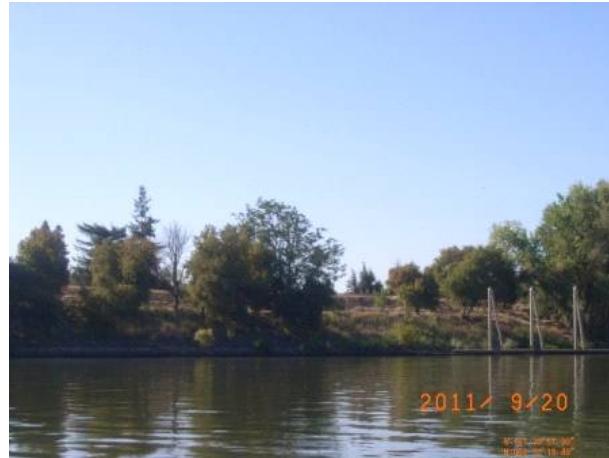
USACE 2011 Photo #1

Levee Mile Report Line	1
Start Levee Mile	0.32
End Levee Mile	0.38
Location	Water Side
Category	Supplemental
Item	USACE Erosion Survey

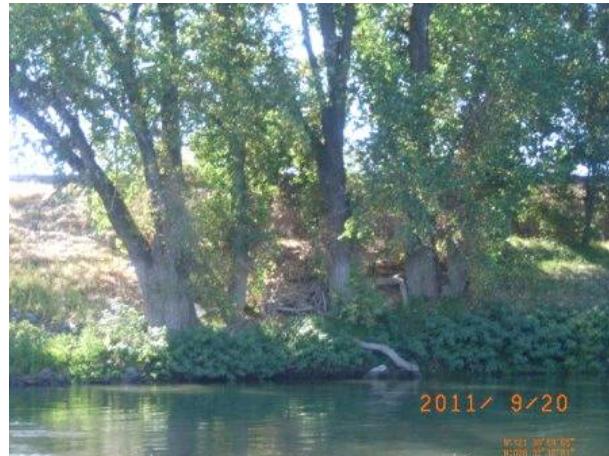
USACE 2011 Photo #2

Levee Mile Report Line	1
Start Levee Mile	0.32
End Levee Mile	0.38
Location	Water Side
Category	Supplemental
Item	USACE Erosion Survey

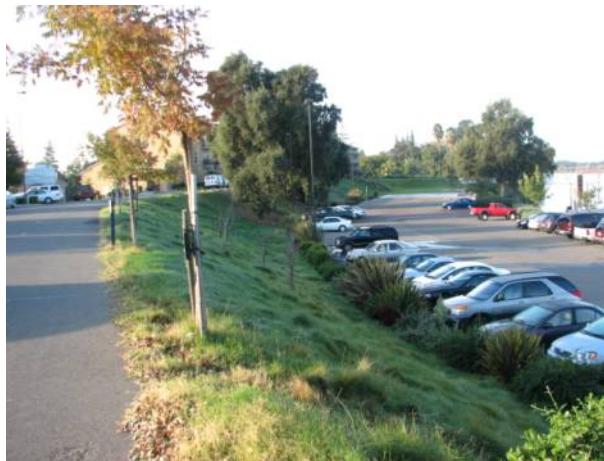
Levee Mile Report Line	3
Start Levee Mile	0.48
End Levee Mile	0.65
Location	Water Side
Category	Earthen Levee
Item	Encroachments
Landscape on the waterside at Le Rivage Hotel. Fall 2011

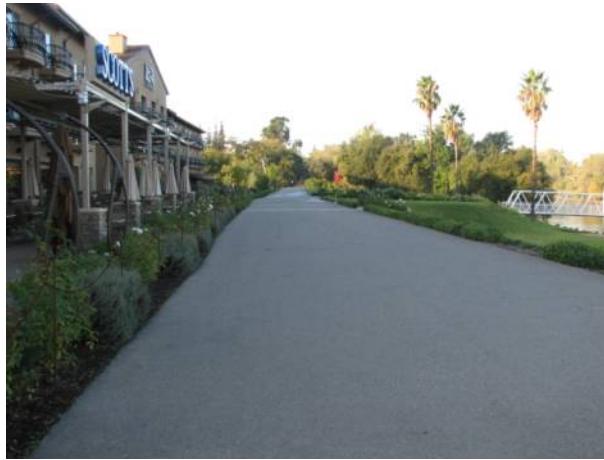
Levee Mile Report Line	3
Start Levee Mile	0.48
End Levee Mile	0.65
Location	Water Side
Category	Earthen Levee
Item	Encroachments
The landscape that is planted on the crown of the levee. Fall 2011

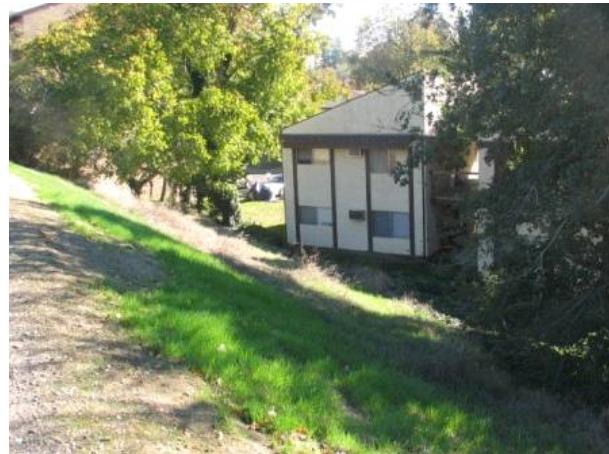
The apartments are within the easement of the levee toe.

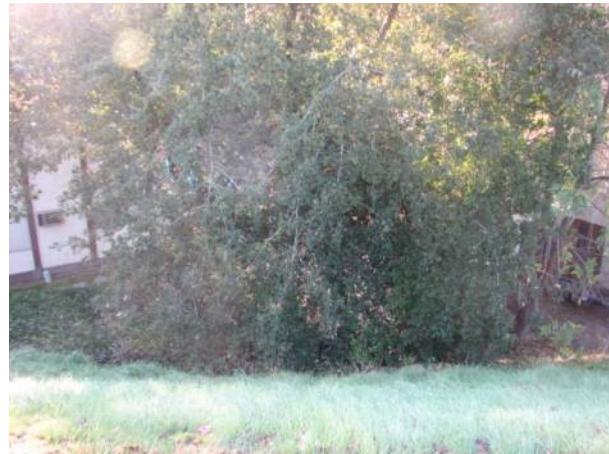
The trees need trimming that are located at the apartments. Fall 2011

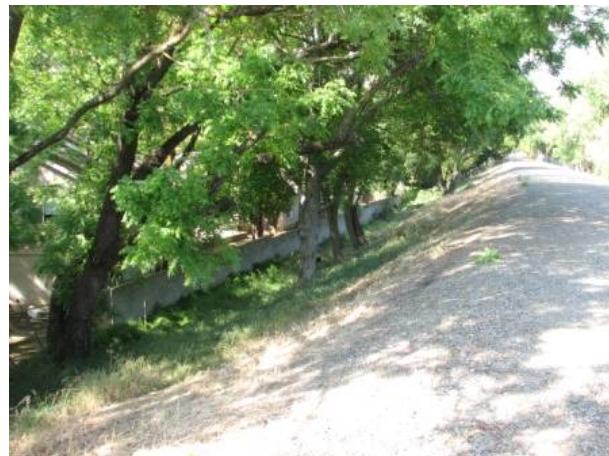
Levee Mile Report Line	9
Start Levee Mile	0.72
End Levee Mile	0.78
Location	Land Side
Category	Earthen Levee
Item	Encroachments
The block wall fence is located at the toe of the levee.	
johngw_f_20111107_861.jpg

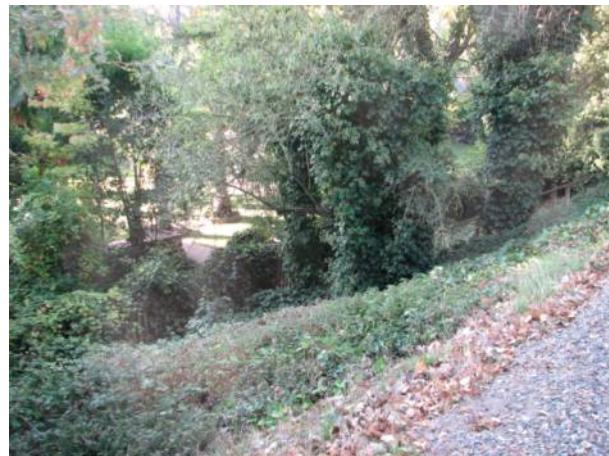
Levee Mile Report Line	15
Start Levee Mile	0.88
End Levee Mile	0.90
Location	Land Side
Category	Earthen Levee
Item	Encroachments
Ivy groundcover completely covers the ground and makes it hard too see seepage. Fall 2011	
johngw_f_20111107_505.jpg

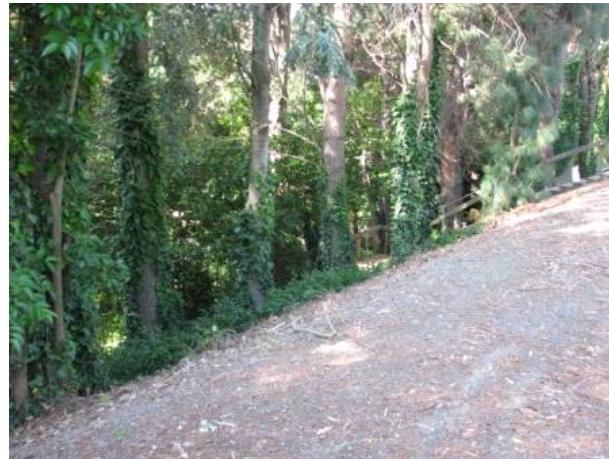
Levee Mile Report Line	20
Start Levee Mile	0.98
End Levee Mile	1.00
Location	Land Side
Category	Earthen Levee
Item	Encroachments
The ivy is overgrown and is climbing the trees.	
<a href="#">johngw_f_20111107_870.jpg</a>

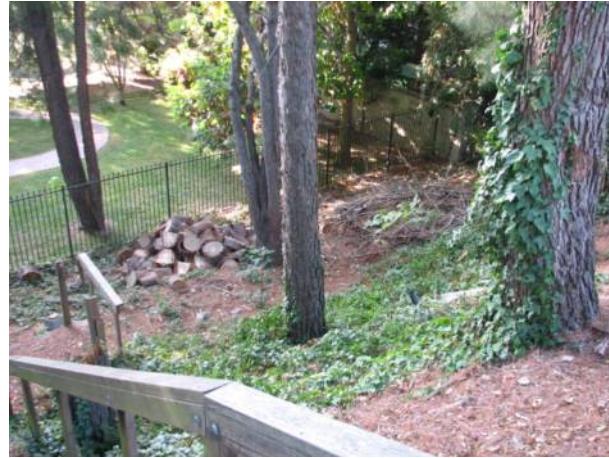
Levee Mile Report Line	21
Start Levee Mile	1.00
End Levee Mile	1.02
Location	Land Side
Category	Earthen Levee
Item	Encroachments
Ivy groundcover covers part of the levee slope and wood debris from trimmings is left at the toe. Fall 2011	
<a href="#">johngw_f_20111107_507.jpg</a>

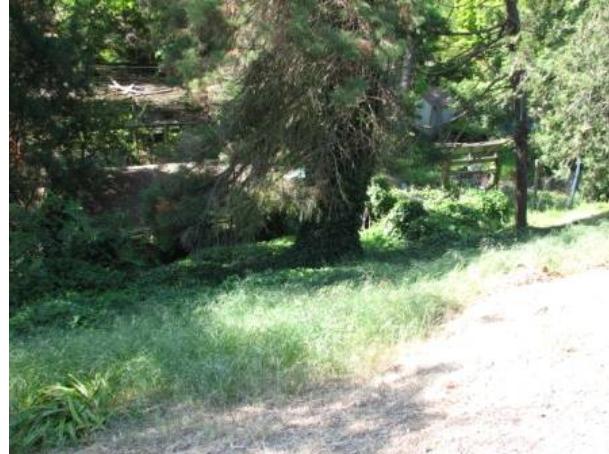
Levee Mile Report Line	23
Start Levee Mile	1.04
End Levee Mile	1.06
Location	Land Side
Category	Earthen Levee
Item	Encroachments
The overgrown landscape makes it hard to see.	
<i>johngw_f_20111007_871.jpg</i>

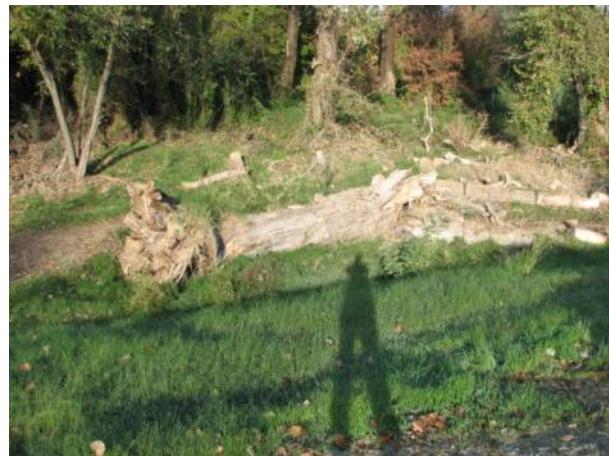
Levee Mile Report Line	28
Start Levee Mile	1.29
End Levee Mile	1.29
Location	Water Side
Category	Earthen Levee
Item	Encroachments
A large cottonwood tree at toe of levee fell. Fall 2011	
<a href="#">johngw_f_20111107_509.jpg</a>

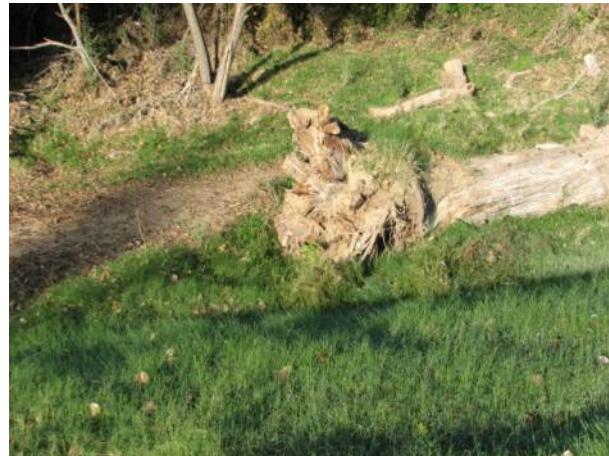
Levee Mile Report Line	28
Start Levee Mile	1.29
End Levee Mile	1.29
Location	Water Side
Category	Earthen Levee
Item	Encroachments
The rootball took a small divot out of the toe of the levee. Fall 2011	
<a href="#">johngw_f_20111107_510.jpg</a>

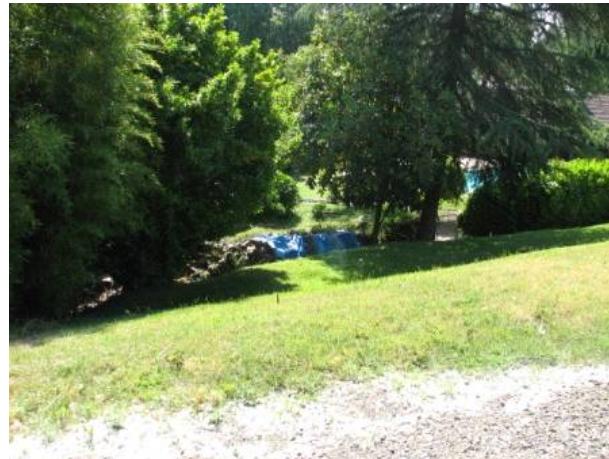
Levee Mile Report Line	30
Start Levee Mile	1.31
End Levee Mile	1.31
Location	Land Side
Category	Earthen Levee
Item	Encroachments
Firewood is stacked along the toe of the levee.	
<i>johngw_f_20111007_876.jpg</i>

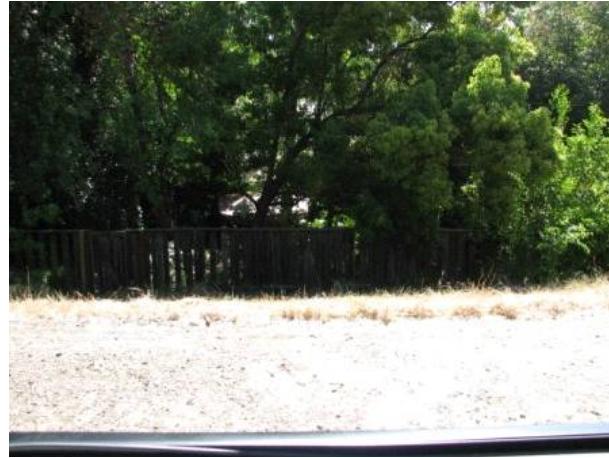
Levee Mile Report Line	31
Start Levee Mile	1.34
End Levee Mile	1.36
Location	Land Side
Category	Earthen Levee
Item	Encroachments
The wooden fence along the toe is hard to see through.	
<i>johngw_f_20111007_877.jpg</i>

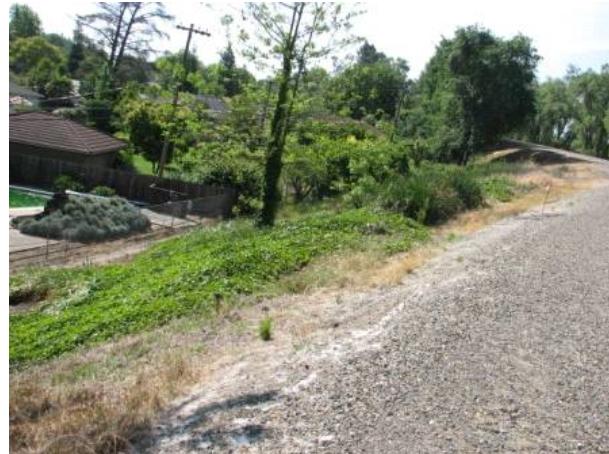
Levee Mile Report Line	33
Start Levee Mile	1.38
End Levee Mile	1.40
Location	Land Side
Category	Earthen Levee
Item	Encroachments
Ivy completely covers the ground.	
<i>johngw_f_20111007_878.jpg</i>

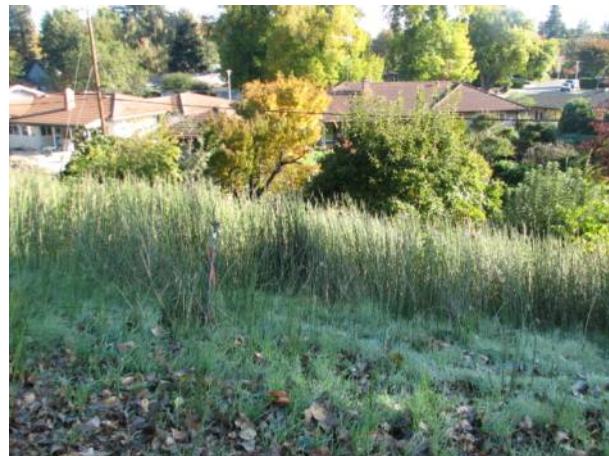
Levee Mile Report Line	34
Start Levee Mile	1.41
End Levee Mile	1.41
Location	Land Side
Category	Earthen Levee
Item	Encroachments
Horsetail vegetation completely blocks levee slope. Fall 2011	
<i>johngw_f_20111107_511.jpg</i>

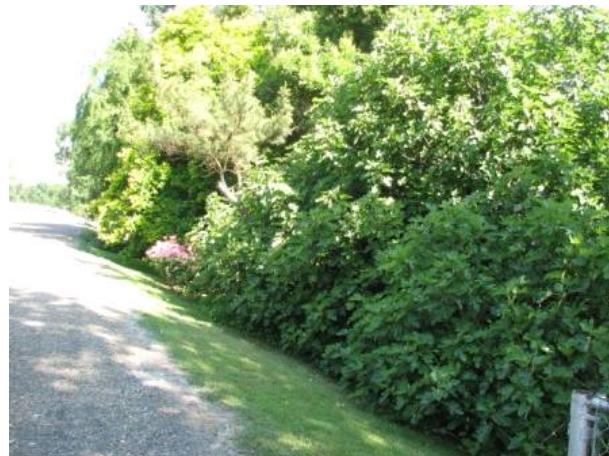
Levee Mile Report Line	36
Start Levee Mile	1.88
End Levee Mile	1.92
Location	Land Side
Category	Earthen Levee
Item	Encroachments
The trees and vegetation makes it hard to see the toe.	
<i>johngw_f_20111007_880.jpg</i>

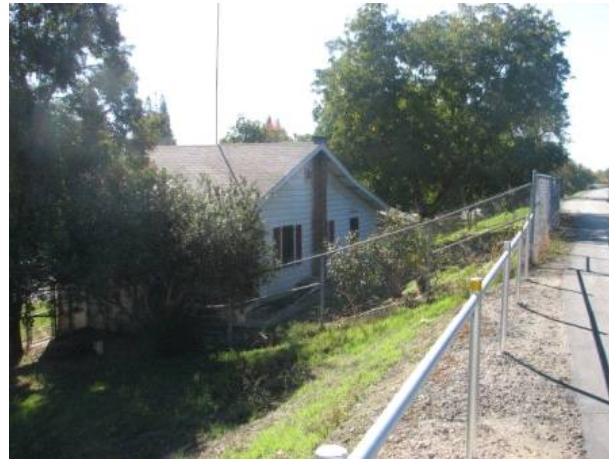
House is located on the levee slope and garden is terraced into the slope.

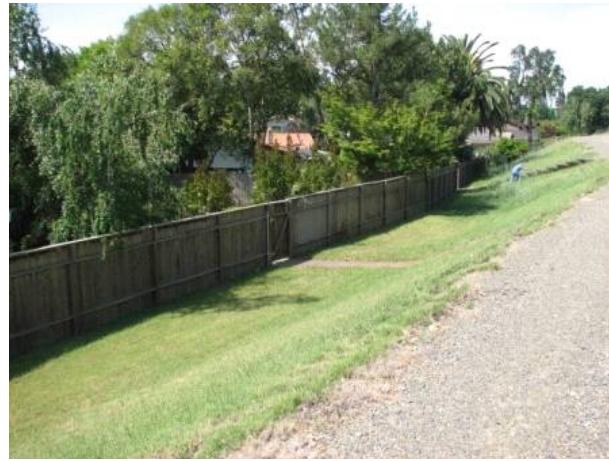
Levee Mile Report Line	52
Start Levee Mile	3.06
End Levee Mile	3.12
Location	Land Side
Category	Earthen Levee
Item	Encroachments
Several homes have solid fences and make it hard to see.	
johngw_f_20111007_886.jpg

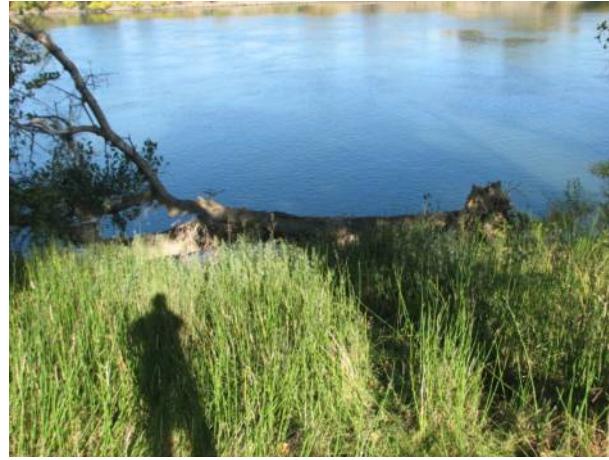
Levee Mile Report Line	55
Start Levee Mile	3.16
End Levee Mile	3.16
Location	Water Side
Category	Earthen Levee
Item	Encroachments
A tree at the water edge has fallen. Fall 2011	
johngw_f_20111107_512.jpg

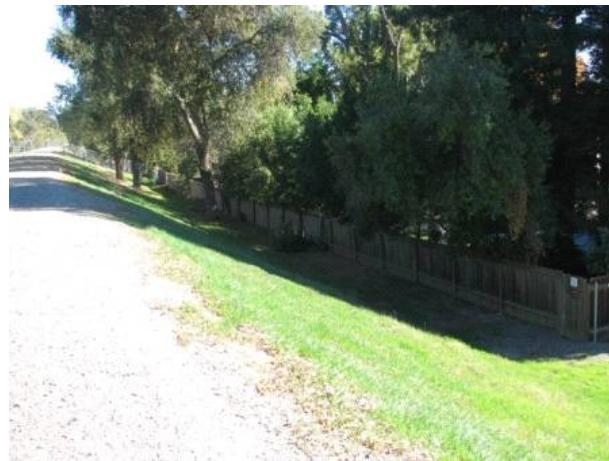
Levee Mile Report Line	70
Start Levee Mile	3.34
End Levee Mile	3.37
Location	Land Side
Category	Earthen Levee
Item	Encroachments
The wooden fence is along the toe of the levee.	
<a href="#">johngw_f_20111107_887.jpg</a>

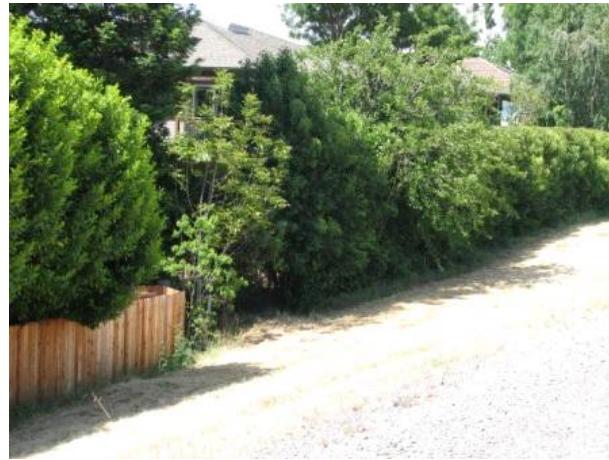
Levee Mile Report Line	71
Start Levee Mile	3.60
End Levee Mile	3.62
Location	Land Side
Category	Earthen Levee
Item	Encroachments
Rebuilding the fence with solid boards. Vines and shrubs completely block visibility.	
<a href="#">johngw_f_20111107_888.jpg</a>

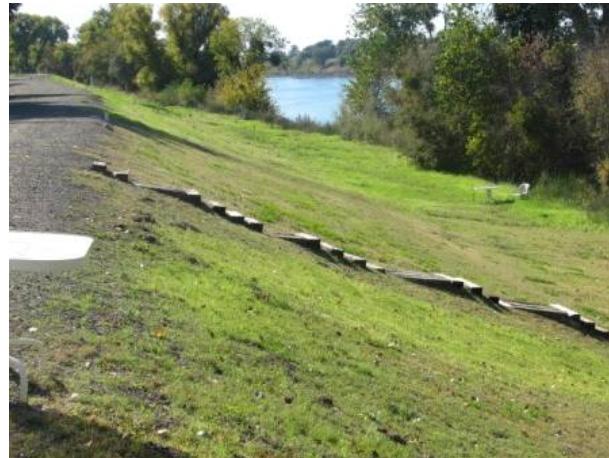
Levee Mile Report Line	93
Start Levee Mile	3.98
End Levee Mile	3.99
Location	Land Side
Category	Earthen Levee
Item	Encroachments
Stairs are on the waterside levee slope.	
<i>johngw_f_20111007_892.jpg</i>

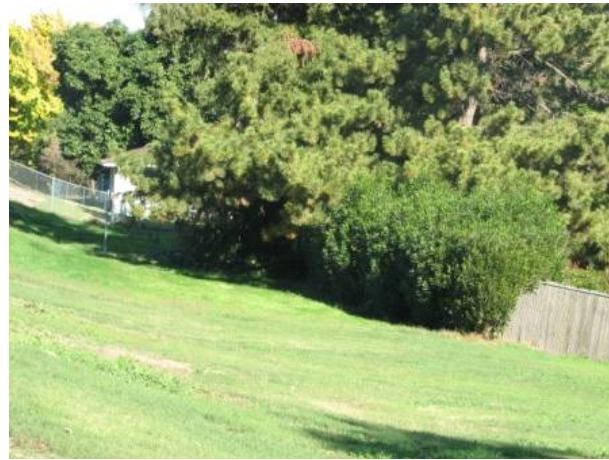
Levee Mile Report Line	103
Start Levee Mile	4.17
End Levee Mile	4.20
Location	Land Side
Category	Earthen Levee
Item	Encroachments
Fenced area with a walk through to the neighborhood. This is the City of Sacramento's property.	
<a href="#">johngw_f_20111107_894.jpg</a>

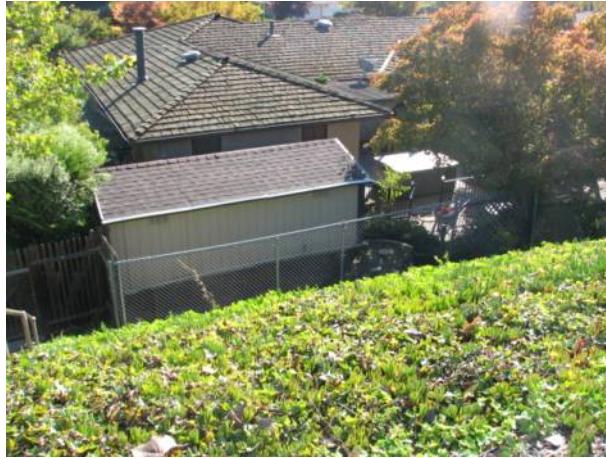
Levee Mile Report Line	117
Start Levee Mile	4.50
End Levee Mile	4.50
Location	Land Side
Category	Earthen Levee
Item	Encroachments
A small shed was built within the easement of the levee. Fall 2011	
<i>johngw_f_20111107_517.jpg</i>

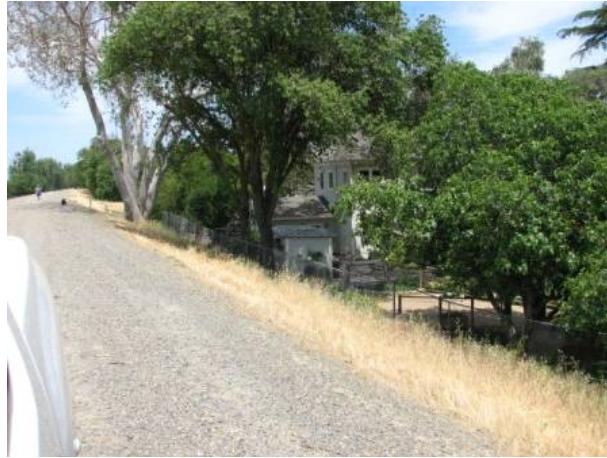
Levee Mile Report Line	137
Start Levee Mile	5.31
End Levee Mile	5.31
Location	Land Side
Category	Earthen Levee
Item	Encroachments
The building encroaches into the levee.	
<i>johngw_f_20111007_901.jpg</i>

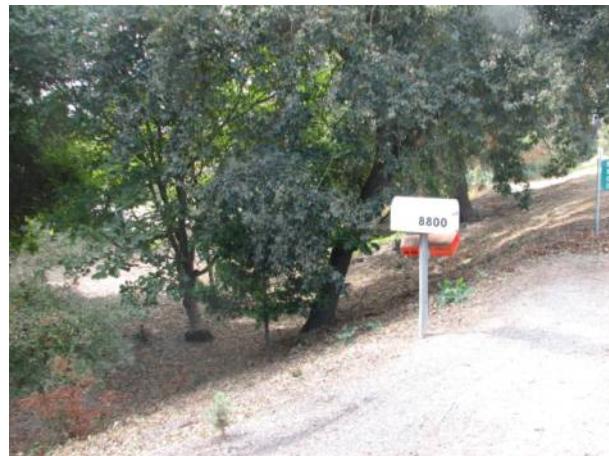
Levee Mile Report Line	190
Start Levee Mile	11.50
End Levee Mile	11.50
Location	Land Side
Category	Earthen Levee
Item	Encroachments
The landscape is planted on the levee slope with the trees and shrubs trimmed up. Fall 2011	johngw_f_20111107_483.jpg

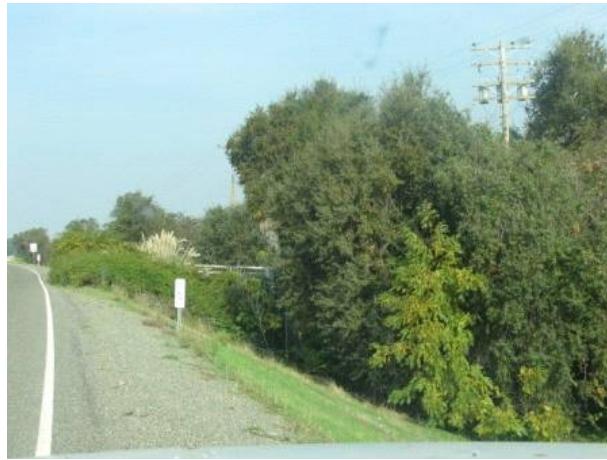
Levee Mile Report Line	201
Start Levee Mile	14.43
End Levee Mile	14.43
Location	Land Side
Category	Earthen Levee
Item	Encroachments
Trees and shrubs planted along the toe and on the slope lining the drive.	johngw_f_20111007_914.jpg

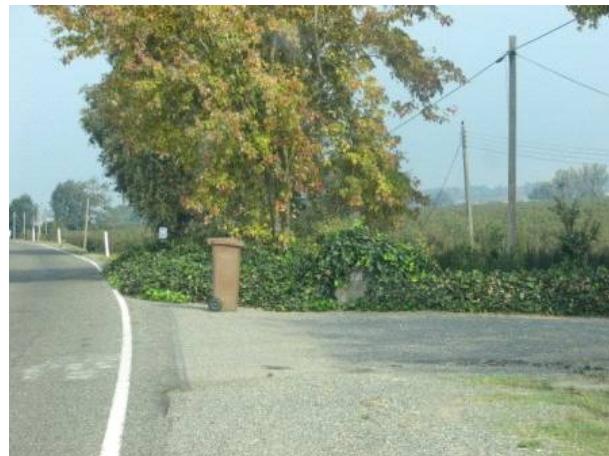
Levee Mile Report Line	204
Start Levee Mile	15.29
End Levee Mile	15.29
Location	Land Side
Category	Earthen Levee
Item	Encroachments
Trees and ivy are plant on the shoulder of the levee.	
johngw_f_20111107_885.jpg

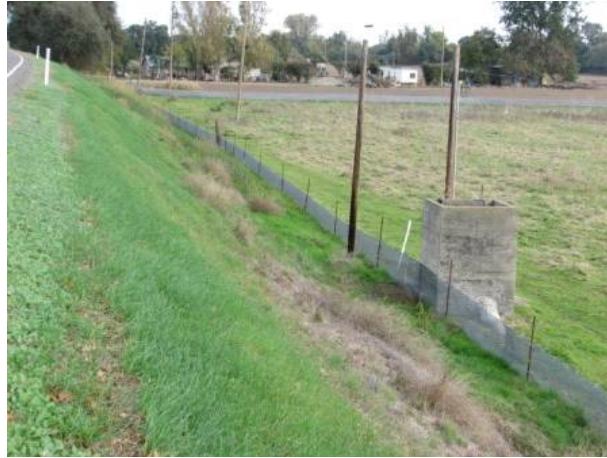
Levee Mile Report Line	208
Start Levee Mile	16.01
End Levee Mile	16.12
Location	Land Side
Category	Earthen Levee
Item	Encroachments
The fence is at toe of the levee.	
<i>johngw_f_20111107_926.jpg</i>

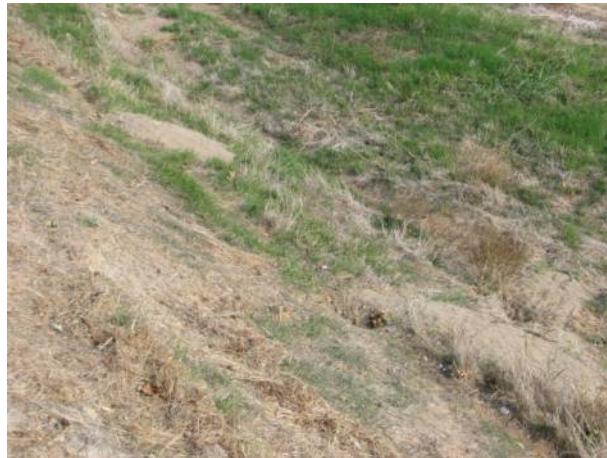
Levee Mile Report Line	215
Start Levee Mile	17.14
End Levee Mile	17.14
Location	Land Side
Category	Earthen Levee
Item	Animal Control
Rodent holes are at the toe of the levee Fall 2011	
<i>johngw_f_20111107_492.jpg</i>

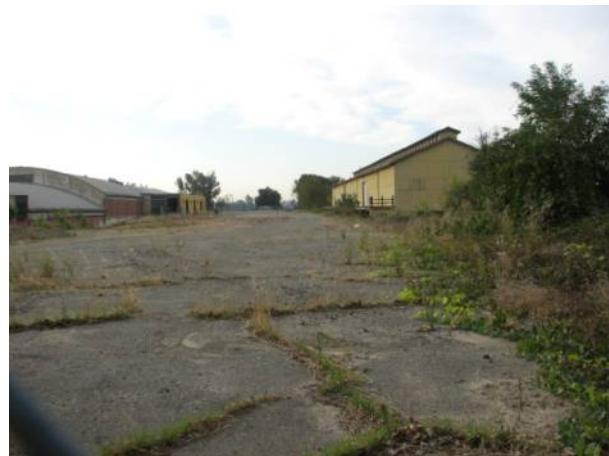
Levee Mile Report Line	218
Start Levee Mile	17.69
End Levee Mile	17.75
Location	Water Side
Category	Earthen Levee
Item	Encroachments
The crown of the levee at the town of Hood. Fall 2011	
johngw_f_20111107_498.jpg

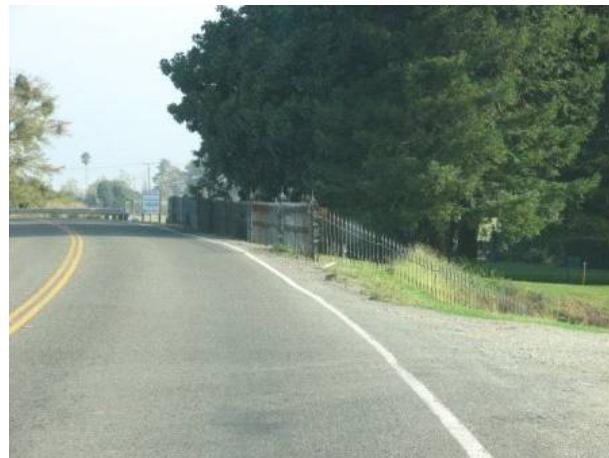
Levee Mile Report Line	221
Start Levee Mile	18.31
End Levee Mile	18.31
Location	Land Side
Category	Earthen Levee
Item	Encroachments
A metal fence is installed along the shoulder of the levee with trees in the yard.	
<i>johngw_f_20111107_879.jpg</i>

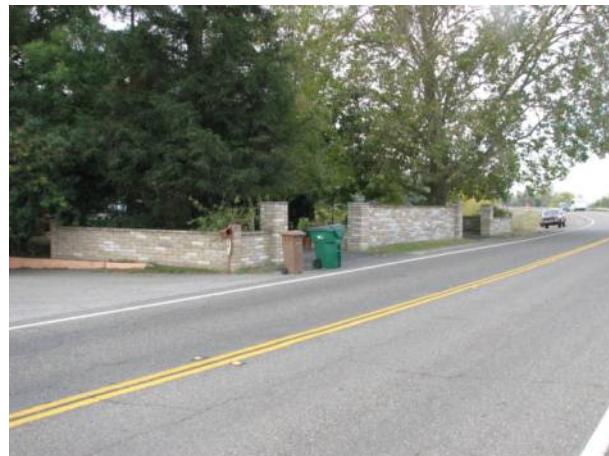
Levee Mile Report Line	224
Start Levee Mile	18.57
End Levee Mile	18.57
Location	Land Side
Category	Earthen Levee
Item	Encroachments
A brick wall separates the roadway and the rest of the landscape on the levee. Fall 2011	
johngw_f_20111107_496.jpg

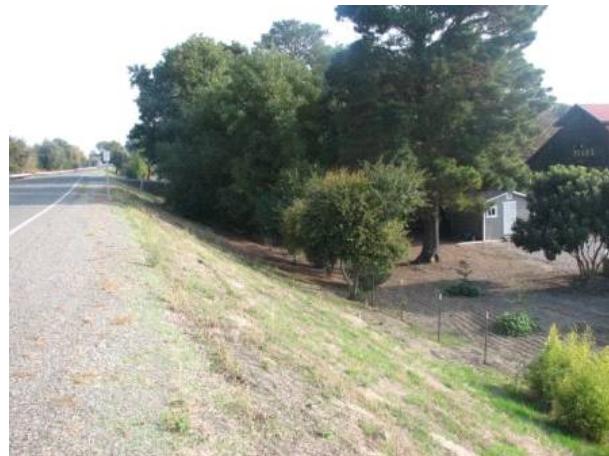
Levee Mile Report Line	227
Start Levee Mile	19.06
End Levee Mile	19.06
Location	Land Side
Category	Earthen Levee
Item	Encroachments
Wire fencing, trees and shrubs are planted along the toe of the levee.	
johngw_f_20111007_909.jpg
